Report of the United Nations Mission to Investigate Allegations of the Use of Chemical Weapons in the Syrian Arab Republic on the alleged use of chemical weapons in the Ghouta area of Damascus on 21 August 2013

Report on Allegations of the Use of Chemical Weapons in the Ghouta Area of Damascus on 21 August 2013

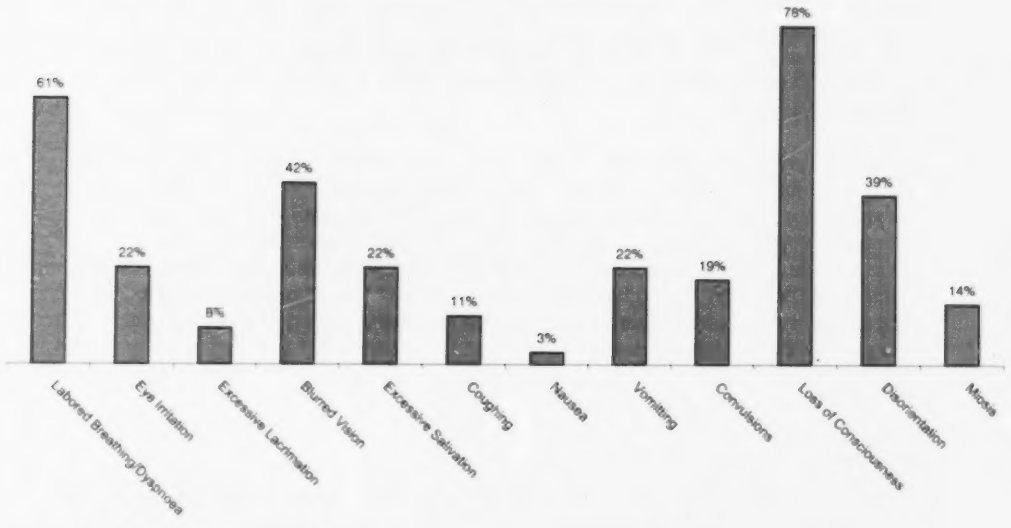
Chart: Symptoms and signs of survivors (N=36)

The main symptoms reported by survivors included loss of consciousness (78%), shortness of breath (61%), blurred vision (42%), eye irritation/inflammation (22%), excessive salivation (22%), vomiting (22%), and convulsions/seizures (19%). The full range of symptoms and signs are presented in the chart below.

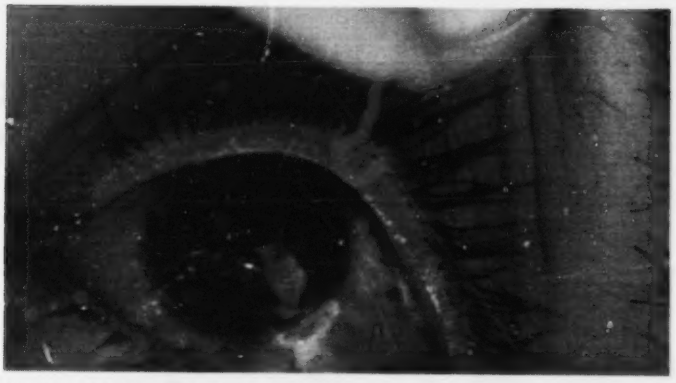
Figure 2: Miosis (constriction of pupils)

Physical examination demonstrated that 39% of survivors were confused or disoriented at the time of the assessment and that 14% had miosis (constriction of pupils) (Figures 2 and 3).

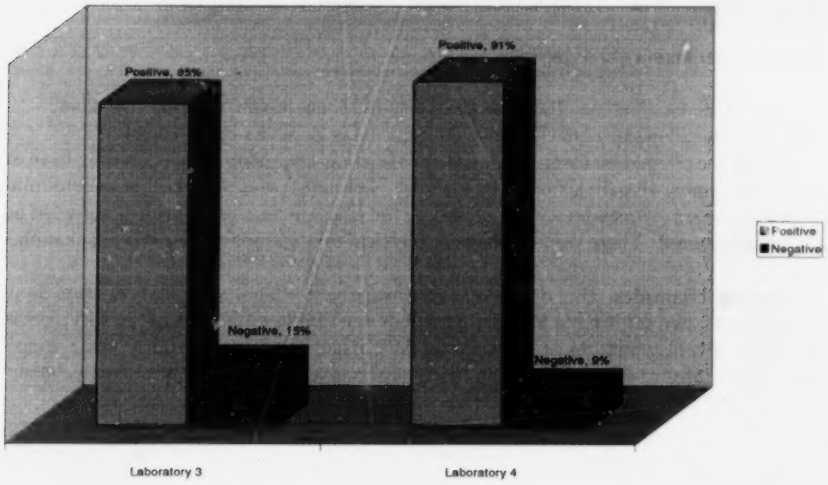
Results of Plasma testing

Conclusion. The positive blood and urine specimens provide definitive evidence of exposure to Sarin by a large proportion of the survivors assessed by the investigation Mission. These results are corroborated by the clinical assessments, which documented symptoms and signs that are consistent with nerve agent exposure, including shortness of breath, eye irritation, excessive salivation, convulsions, confusion/disorientation, and miosis. The findings of the clinical assessments were consistent with information derived from both the interviews with clinicians and the review of medical records, which each reported symptoms and signs consistent with nerve agent exposure.

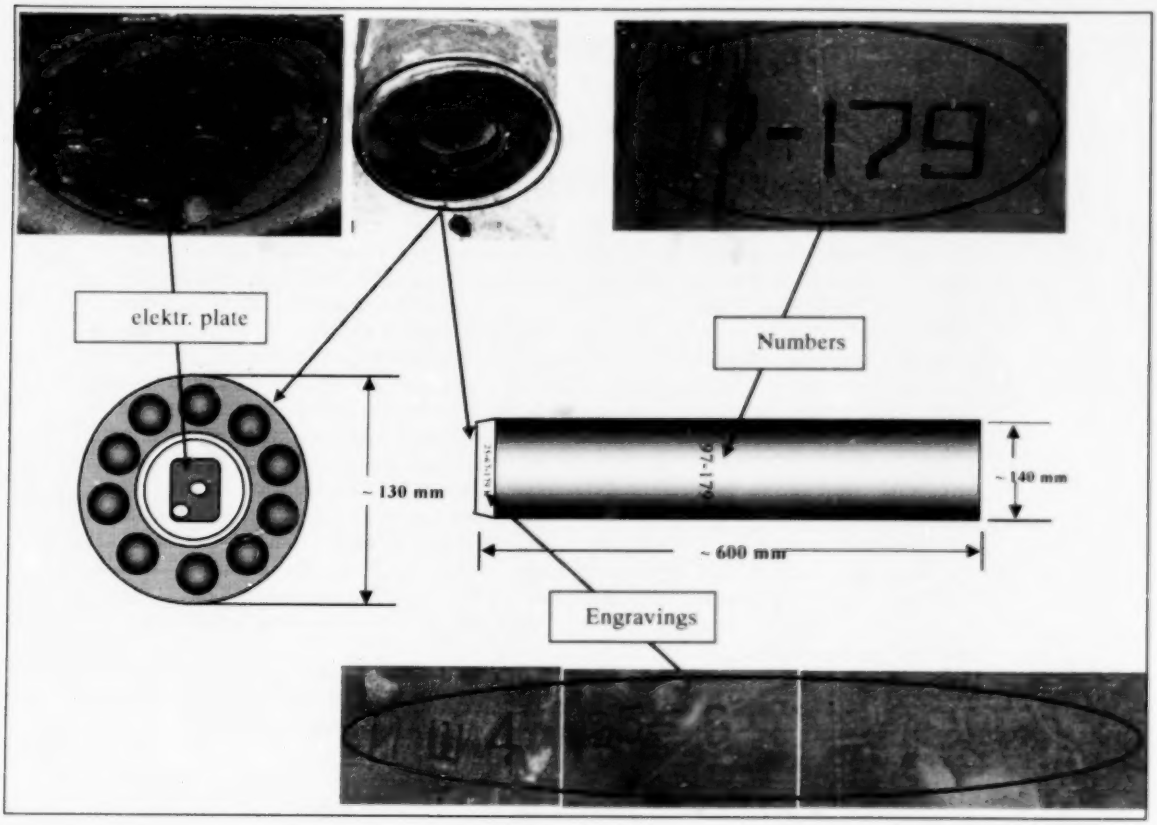
Limitations:
The time necessary to conduct a detailed survey of both locations as well as take samples was very limited. The sites have been well travelled by other individuals both before and during the investigation. Fragments and other possible evidence have clearly been handled/moved prior to the arrival of the investigation team.

Observations and assessments from the Zamalka/Ein Tarma findings:
One team moved to the location of an alleged munition impact located on the roof of a five story building, the second team moved to another alleged impact point located in a nearby open field. The two teams worked in parallel and identified the same type of munition at both sites. The munition had features noted as being consistent with that of an unguided rocket. All measurements and dimensions are the result of both team findings. Some rocket parts were deformed on impact and the measurements should be considered as best estimates. Based on the orientation of the impact craters, orientation of certain surviving munition components and other damage in the areas, the rockets are believed to have arrived from the northwest.

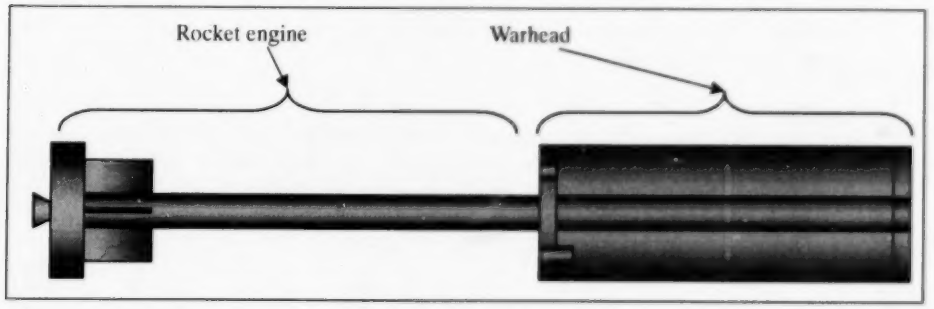
Below is a drawing of the found ordnance, the body has been divided into two parts.

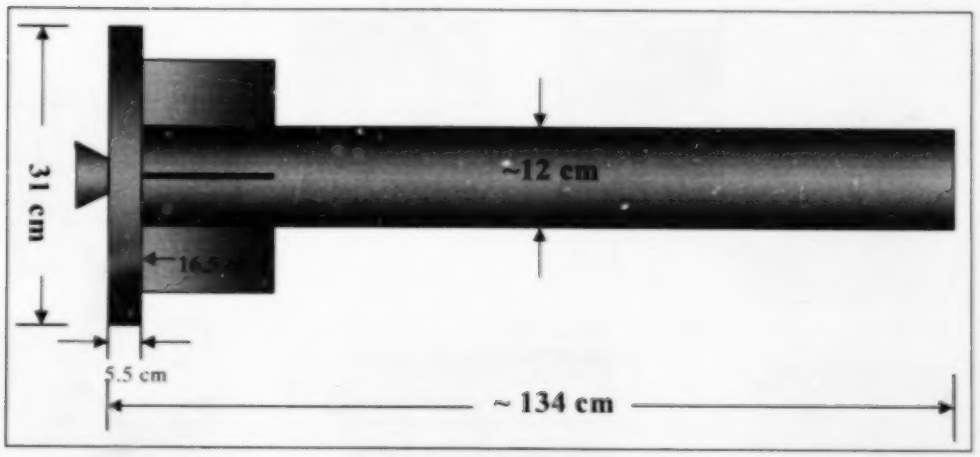
The rocket engine:
Six stabilizer fins are equally arranged in a circle and stabilized with a metal ring.
One rocket had a red number 153 sprayed in the middle of the engine tube.
The engine tube is attached to the warhead with 12 bolts.

- Total length of the engine: ~134 cm (exit nozzle not included)
- Length of rocket motor fins: ~16.5 cm
- Width of stabilizing ring: ~5.5 cm
- Length of motor exit nozzle: ~4.5 cm
- Length of motor engine shaft: ~112 cm
- Ø of engine shaft: ~12 cm
- Ø of stabilizer ring: ~31 cm

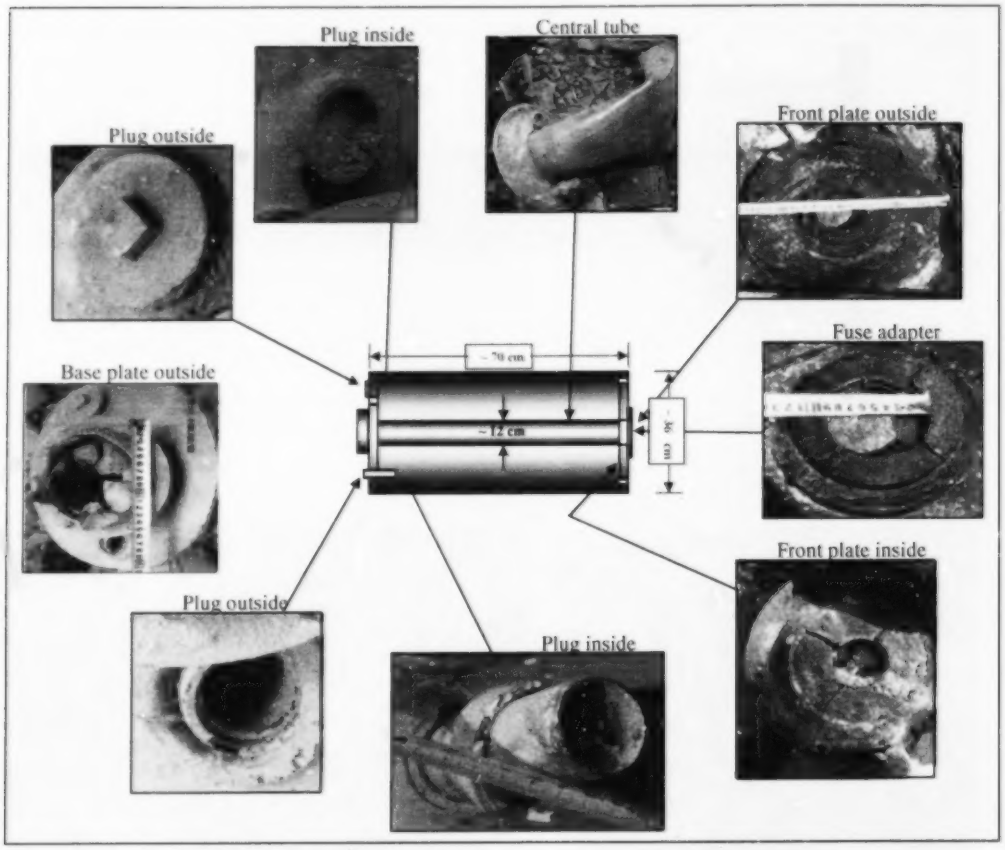
The warhead consists of:

- Front metal plate with a fuse thread in the center
  - Ø outside: ~ 36 cm
  - Ø fuse thread: ~ 9 cm

- Six threaded attachment holes are equally arranged in a circle near the outer ring

- Body / outer container consisting of metal plate
  - Thickness ~ 5 mm
- Metal base plate with filling plug, tube and attachment ring with 12 bolts.
  - Ø outside: ~ 36 cm
  - Ø square bolt ~ 7 cm
  - Ø integrated tube on the base plate ~ 3 cm
  - Length of the tube ~ 10 cm
- Central tube of the warhead
  - Length of tube: ~ 70 cm
  - Ø of the tube: ~ 12 cm

Liquid capacity of the warhead:
The approx. capacity of liquid in the warhead is according to the measurements between 56 ± 6 liters. This calculation is exclusive to the thickness of the container walls and any other unknown components possibly contained in the warhead.

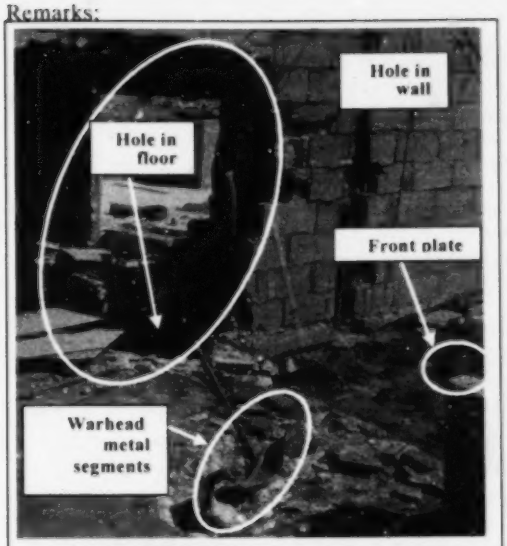
1. The rocket found by the sub-team on the roof penetrated a cinderblock wall and a rebar containing concrete floor before coming to rest in a room below. The suspected front plate of the warhead and other parts suspected of being the warhead casing were found in front of the first wall and not in the lower room. Additionally, they did not exhibit signs of significant deformation or damage due to kinetic impact. Based on the found evidence; there is an indication that the rocket warhead appeared to function prior to impacting on the roof, releasing its contents and depositing the discovered fragments before travelling through the structure to its terminal location. Apart from the rocket motor and the front central tube with the base plate, no other munition fragments were found in the lower room.

2. The front plate showed 6 symmetric threaded holes around the outline. It's unclear what part(s) are attached through these holes.
